The Effects of Oxidation-Induced Failures on Thermal Barrier Coatings with Platinum  
Aluminide and NiCoCrAlY Bond Coats

N. M. Yanar, G. H. Meier and F. S. Pettit  
Materials Science and Engineering Department  
University of Pittsburgh  
Pittsburgh PA 15261

December 1, 2001

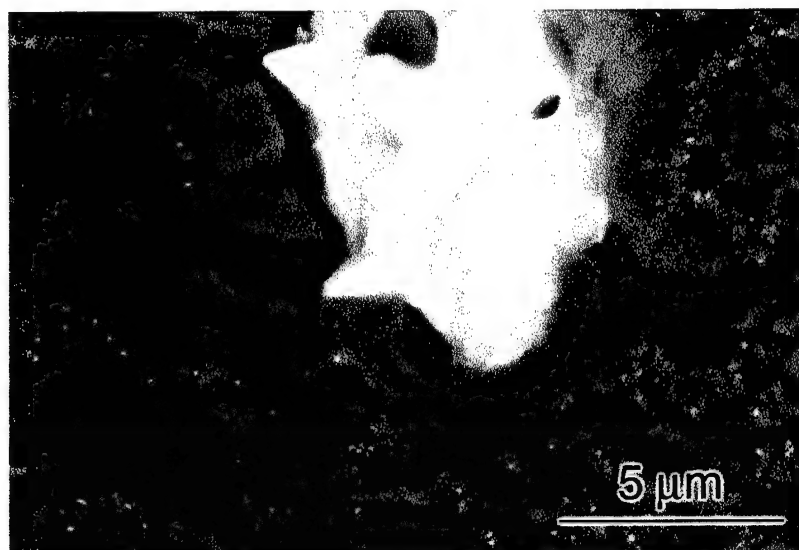
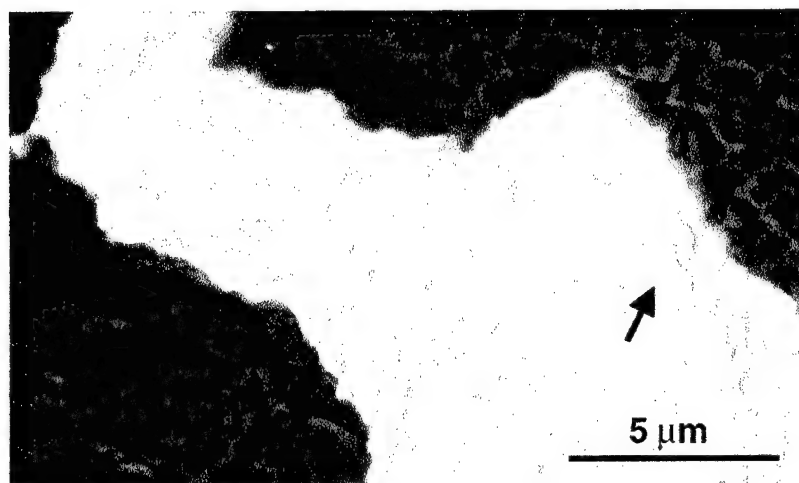
Figure 11. After cyclic oxidation of the platinum-aluminide coatings, refractory metal rich phases (tantalum and tungsten) were evident at the oxide-coating interface, (a) and (b). Such phases were also observed at grain boundaries in the coating, (c).

Before discussing the results obtained with the state-of-the-art TBC systems the oxidation characteristics of the bond coats without TBCs will be described. Both of the NiCoCrAlY bond coats and the platinum aluminide bond coats were cyclically oxidized at 1100° and 1200°C in the same furnace that was used to test the TBC specimens. The surface of the platinum aluminide bond coat became severely deformed during oxidation, Figure 9a, and voids developed in the bond coat just beneath the TGO. When the TGO above the void cracked, oxide was evident on the surface of the void, Figure 9b. The oxide scale did not spall excessively from the platinum aluminide bond coat but cracks were evident, Figure 10, in the alumina scale after cyclic oxidation. In cases where the alumina did spall it was not unusual to observe a refractory metal rich phase at the coating-TGO interface, Figure 11. Such phases were also observed at grain boundaries in the bond coat Figure 11c.

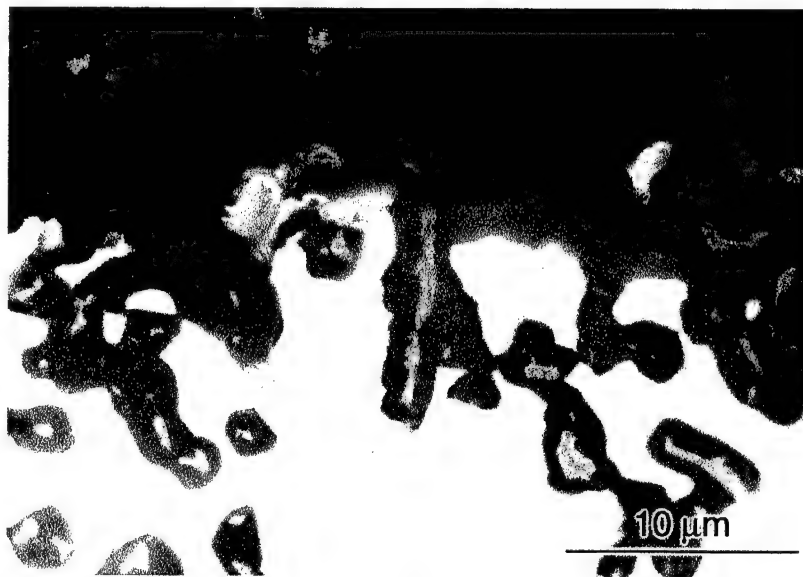
Figure 12. Scanning micrographs of NiCoCrAlY A showing cross sections of this coating after 209, (a) and (b), and 955, (c) and (d), cycles of exposure at 1100°C. Oxide protrusions extended into the coating at locations where yttrium rich oxides had been formed, (d).

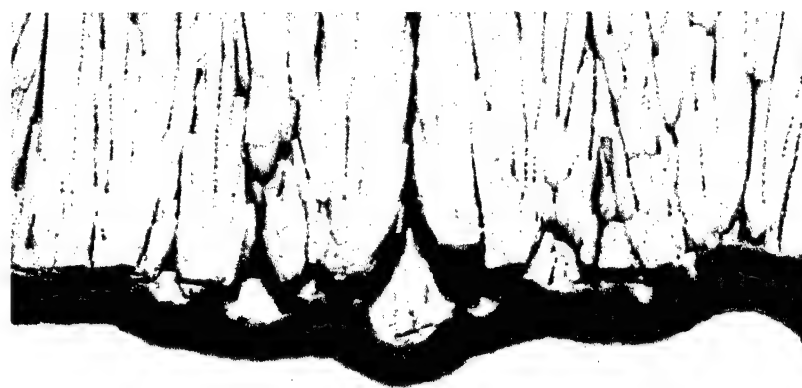
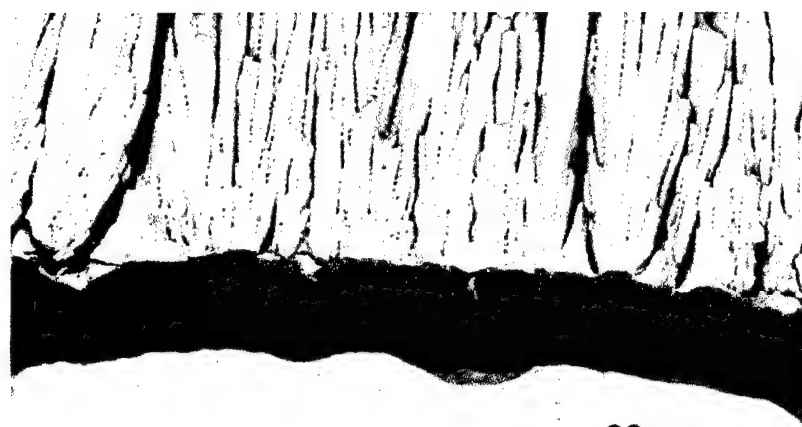
Figure 16. Scanning electron micrographs from the TBC system with platinum aluminide bond coat prior to failure (after 758 cycles of exposure at 1100 °C ) The detachment was observed to be in the TBC, TGO or along the TGO/TBC interface when numerous ratchets were present, (a), whereas it was along the TGO/bond coat interface when ratcheting was less pronounced, (b).

A substantial difference between the failure times for the platinum aluminide bond coats A, B and C was not apparent, Table 3. Furthermore, the failure characteristics were also similar. The TBC failures on the platinum aluminide bond coats occurred in the TBC near the TGO, Figure 14, and at times along the TGO-bond coat interface. When failure was in the TBC near the TGO, ratcheting<sup>(11)</sup> had occurred during cyclic oxidation, Figure 14. This ratcheting caused pieces of the TBC to become detached as shown in Figure 15. In those areas where ratcheting was not excessive, the failure proceeded along the TGO-bond coat interface, Figure 16.

The failures in the case of the TBCs on the platinum aluminide bond coats were essentially the same as those for the state-of-the-art platinum aluminide TBCs. Ratcheting of the TBC and TGO was evident, Figures 14, 15 and 16. The specimens that were given the light grit blast and the media finish had failure times of 1780 and 2280 cycles, respectively, which are significantly larger than failure times for the state-of-the-art TBCs. In Figure 27, cross sections of the as-processed TBCs with the light grit blast and the media finish are presented. The TGOs on these specimens are more smooth compared to the TGO on heavy grit blasted specimens, Figure 6a. The exposed specimens with the light grit blast and media finish surface conditions that failed have not been examined in detail as yet. Based upon the results available it appears that TBCs on platinum aluminide bond coats fail when the strain energy in the TGO exceeds the fracture toughness of the TGO-bond coat interface. Ratcheting<sup>(11)</sup> leads to premature TBC failures and smooth bond coat surfaces, Figure 27, result in longer TBC lives because ratcheting is less severe. Void formation was also evident in bond coats after TBC spallation, Figure 28. These voids developed at grain boundaries in the bond coat, Figure 28. At present the role of voids in the bond coat on TBC failures is not understood and more work is required to attempt to understand void development in bond coats.
